RESEARCH AND DEVELOPMENT REPORT
REPORT 1026
17 MARCH 1961

Investigation of Sonar Diaphragm Coatings

J. C. Thompson, R. K. Logan, and R. B. Nehrich

U. S. NAVY ELECTRONICS LABORATORY, SAN DIEGO, CALIFORNIA
A BUREAU OF SHIPS LABORATORY

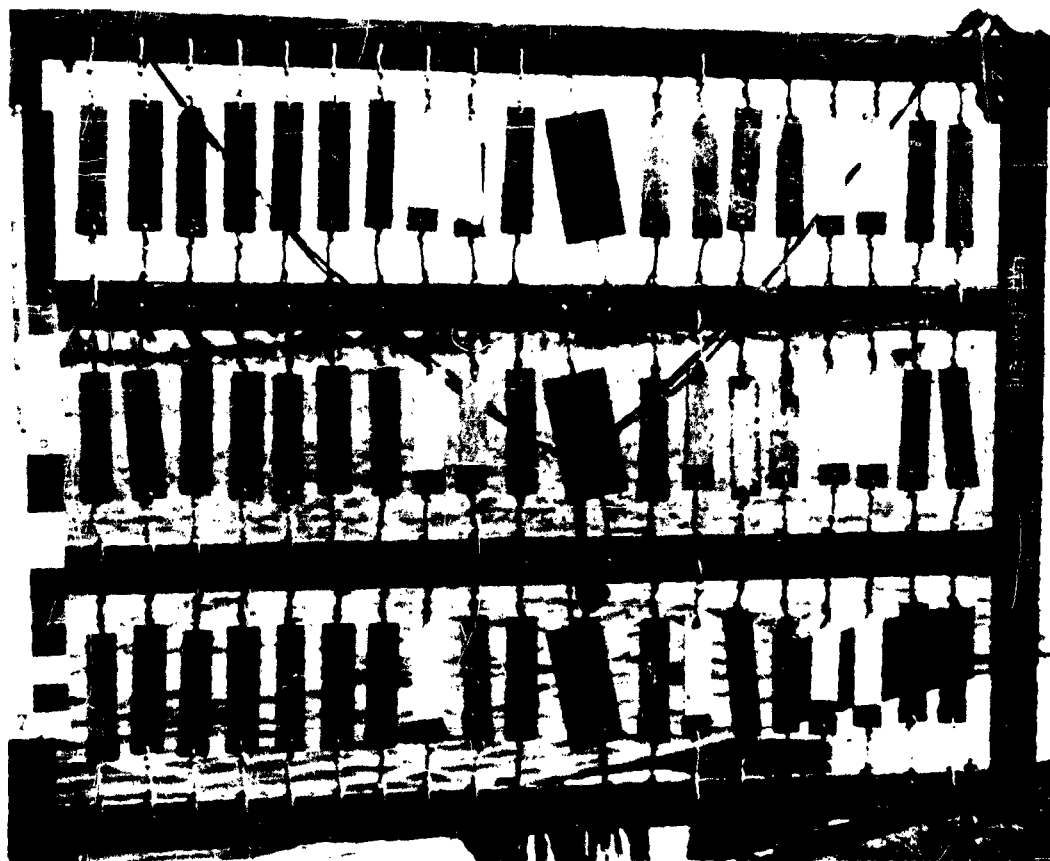
A wooden rack approximately 50 inches wide and 40 inches high was constructed of 1 x 2-1/2-inch stock. Two pieces were added to divide the vertical dimension into three equal open panels. This permitted the mounting of three sets of samples, one under the other, approximately one foot apart (fig. 3). Eye bolts were provided at the bottom for attaching lead weights to the bottom of the frame and at the top for hanging the rack in the water. The test panels were hung using vinyl-covered copper wires. Separate wires were attached to the ends of the specimens and passed through equally spaced holes in the horizontal frame members. Thus the specimens were held equidistant in a fixed position against the action of the tides and were prevented from striking together and undergoing mechanical damage.

The completed rack assembly was transported to the piers at the NEL waterfront area and lowered on the north side of the main docking facility to a water depth of approximately 15 feet. This position was chosen because the area is seldom used for docking the larger boats and also to negate the possible effects of sunlight. The area chosen is on the bay side of the peninsula where contamination and the rapid action of the water during tide runs are believed to have

Figure 3. Samples mounted on wooden rack for bay immersion test.

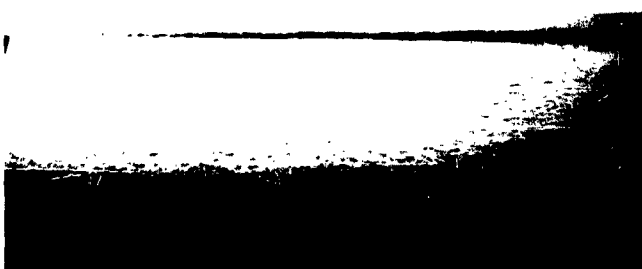
Figure 8. Small cracks after bend test.

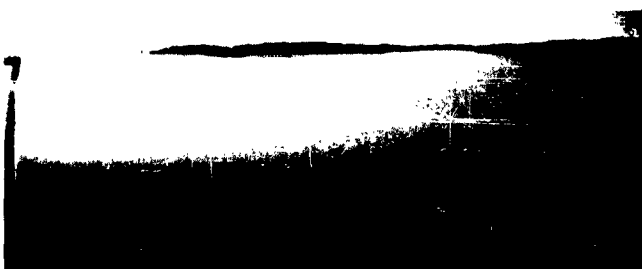
Figure 10. Good result after bend test.
